### **Copper's development on roof & façade generally**

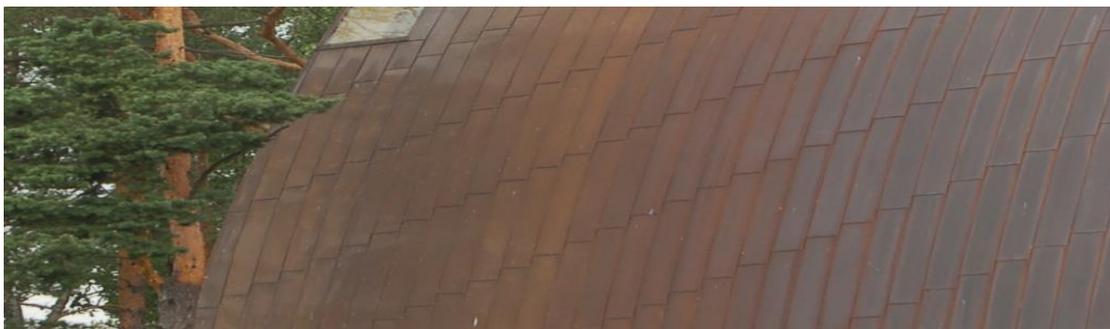
Organic acid fumes from the tree may cause slight colour difference even in a same facade

When using copper below or in conjunction with mortar, cedar/trees, cement and other materials which can leach acids. Leaching acids may discolour oxide and patina as well retard the forming of the protective oxide layer on copper.

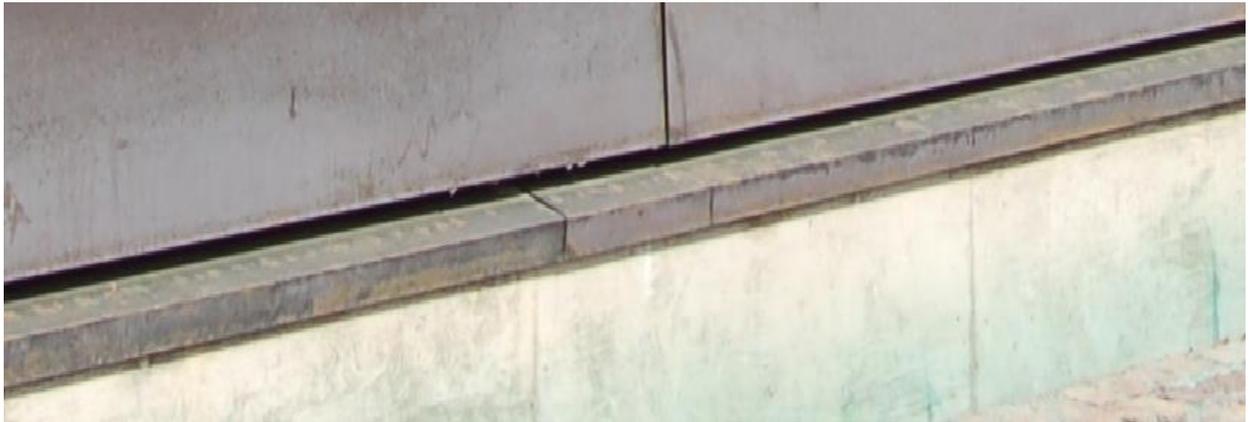
Example of copper staining on cement

The natural weathering of copper results in the formation of copper salts at the surface of a copper sheet. These salts are then mixed with rainwater and if allowed to run on to other materials will cause the characteristic greenish/blueish staining. To prevent such stains, the use of longer overhangs, sloping of copper surfaces away from other materials, gutters, and drip edges are all recommended.
